Turbo Coolant Line Kit

AFTERMARKET EXCLUSIVE | **MAKE A BETTER REPAIR**

926-187

2011-2016 Ford F150, 2015-17 Lincoln Navigator, 2015-2021 Ford Transit 3.5L

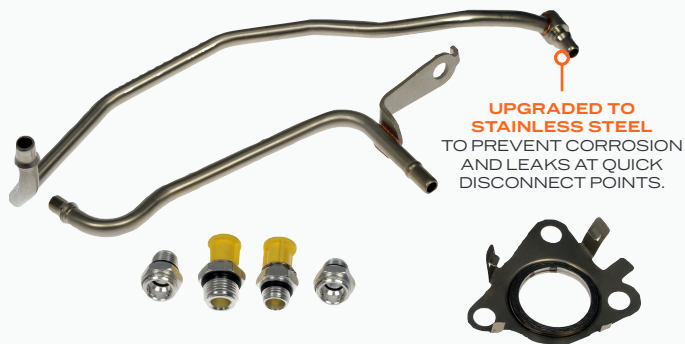
The turbocharger coolant line on certain Ford and Lincoln vehicles often rusts and leaks at the junction point where it meets the quick disconnect fittings. The resulting coolant loss can lead to engine damage. Replacing it with an OEM coolant line could mean the same issue again in the future, a costly proposition with the labor guide calling for over nine hours to replace these parts.

This Dorman OE FIX turbocharger coolant line replaces the OEM regular steel line with a stainless steel line for a more durable replacement that helps prevent future leaks. In addition, this is a complete kit to service the turbo coolant lines, including the supply line, return line, connectors and turbo mounting gasket.

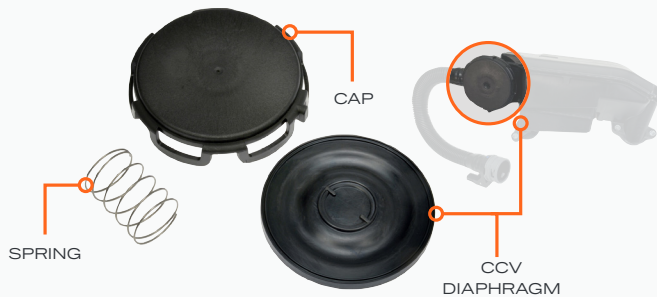
918-359

The diesel engine on certain Ford Super Duty trucks has a large and complex air separator box assembly on the engine that filters crankcase blowby gasses before they are re-introduced back into the engine intake. On this type of engine system, the PCV valve diaphragm becomes clogged with oil and carbon deposits, leading the air separator assembly to fail. This causes excessive crankcase pressure, resulting in oil leaks, high idle and a decrease in engine performance.

This Dorman OE FIX PCV valve diaphragm allows the replacement of just the failed diaphragm instead of the whole separator assembly to reduce cost and downtime of the truck.

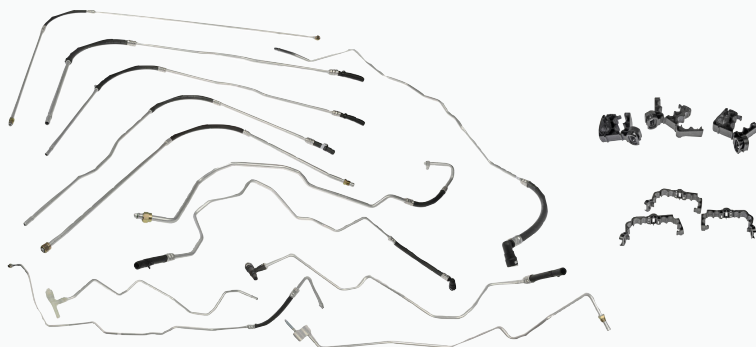
926-866

Routing a one-piece rear A/C line through certain GM SUVs can be a frustrating and time-consuming job.

This Dorman OE FIX multi-piece kit simplifies the installation of rear A/C lines. Each section is engineered to be joined together with a threaded fitting for a leak-free repair.

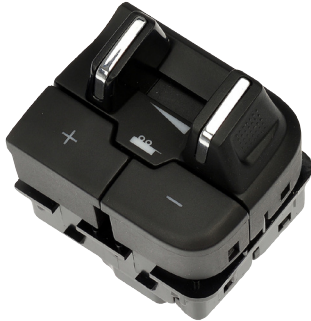
601-235

- Helps enable the addition of trailer brakes, or is a reliable replacement for an original switch that has failed due to electrical malfunction
- Made from quality materials and components to ensure reliable performance and a long service life

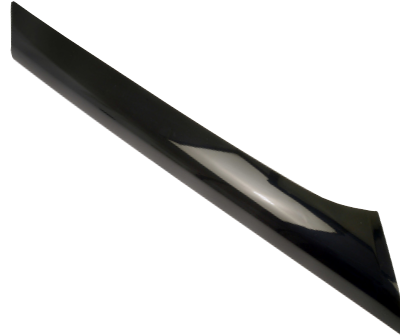
926-289 (Left) | 926-290 (Right)

Windshield A-Pillar Moldings (Black)

- Restores like-new appearance to the windshield pillars when the originals have become deformed or detached
- Direct replacements that match the fit and appearance of the originals and require no special tools to install

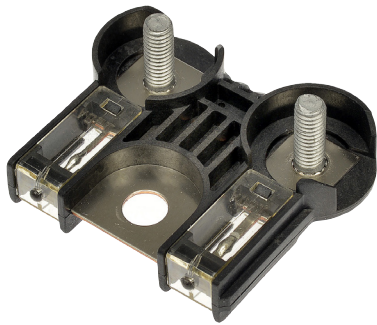
956-356

Battery Circuit Fuse

- Reliable replacement for an original fuse that is missing or has failed

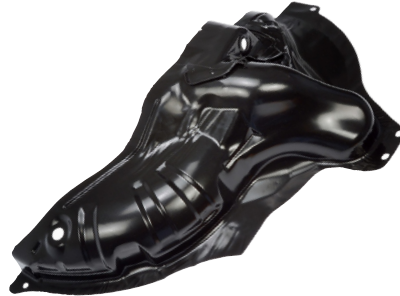
999-987

- Welds into place and matches the fit and appearance of the original shock absorber mount
- Allows a permanent fix that helps to ensure the structural integrity of the body and shock mount and avoid a failed state inspection
- Made of rugged stamped steel, with a corrosion-resistant E-coat for a reliable repair

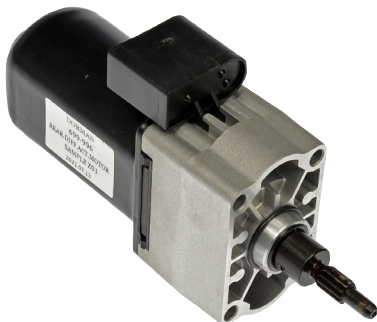
699-996

- Designed, manufactured and tested to strict specifications for reliable service
- Restores the correct distribution of power to the rear differential on specified vehicles

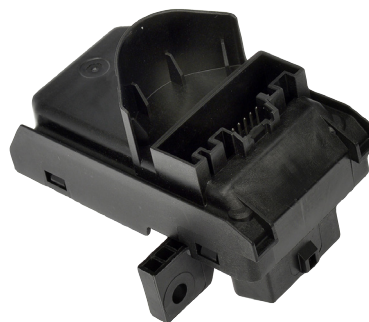
601-620

- This OBD-II data link module matches the function of an original module that has failed due to electrical malfunction or data corruption
- Engineered and tested to restore communications between the controller area network bus and devices and tools that utilize the onboard diagnostic port
